CONDENSING ROOFTOP UNITS FIELD STUDY SUMMARY REPORT

MARCH 2020

PROJECT OVERVIEW

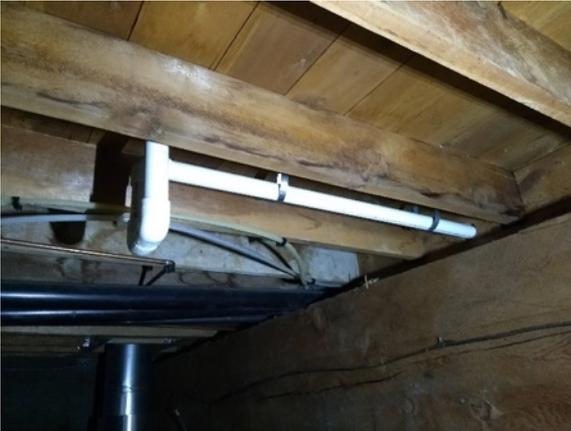
DRAIN PENETRATION & P-TRAP BELOW UNIT

The condensate drainage system ran through the roof curb into the attic space above the restaurant dining area. The installing contractor used 1 ¼" PVC pipe and field-installed a 6" P trap directly below the unit in the attic. The piping runs about 12 feet into the kitchen space and down a column before being reduced to 1". It then runs into a condensate neutralizer tank (Axiom NT25 NeutraPro) and is discharged into an open-floor drain to a sanitary sewer. A stainless-steel platform was fabricated by the site to fulfill a kitchen staff request that the neutralizer tank be installed above the floor to allow for cleaning. The installing contractor followed NEEA's Condensate Management Best Practices and all manufacturer recommendations.

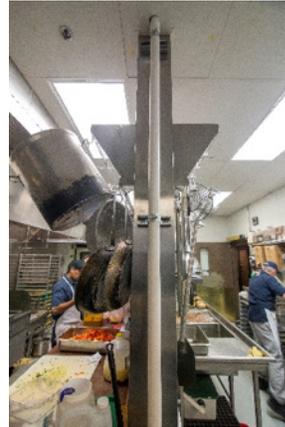
DRAIN ENTERING KITCHEN

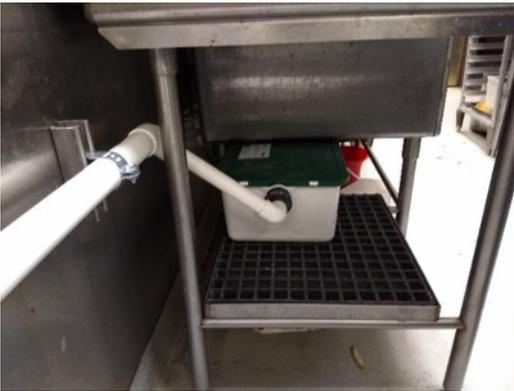
CONDENSATE NEUTRALIZER TANK

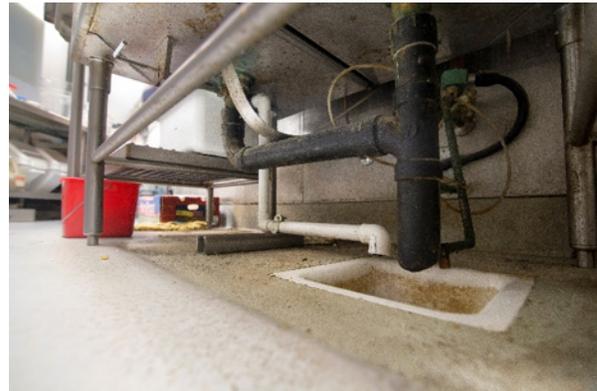
CONDENSATE DRAIN TERMINATION

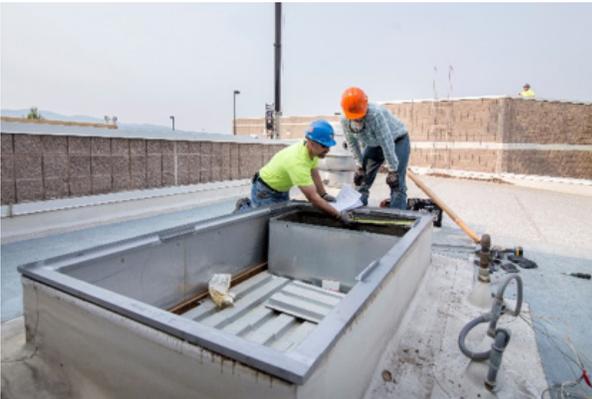
UTILIZING EXISTING ROOF CURB WITH CURB ADAPTER

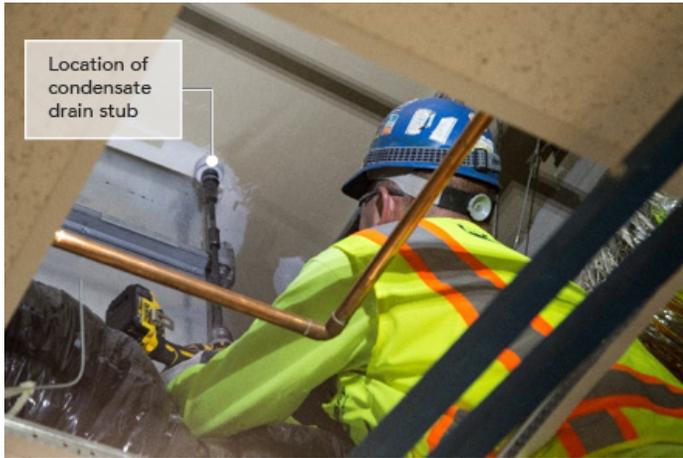
CONDENSATE DRAIN PENETRATION
(CEILING OR BOTTOM VIEW)

The condensate drain installation for Site B was one of the most challenging and labor-intensive tasks among the four installations, requiring 42.75 hours of labor. The closest approved plumbing drain was located in a cafeteria kitchen about 50 feet horizontally from the C-RTU. The piping is located above a corridor with a 4-foot-high space concealed by a T-bar ceiling. The condensate stub was located between the downward discharge supply duct and the inside edge of the roof curb. There was very little clearance between the duct and curb due to the location of the condensate fluid's exit from the bottom of the C-RTU.

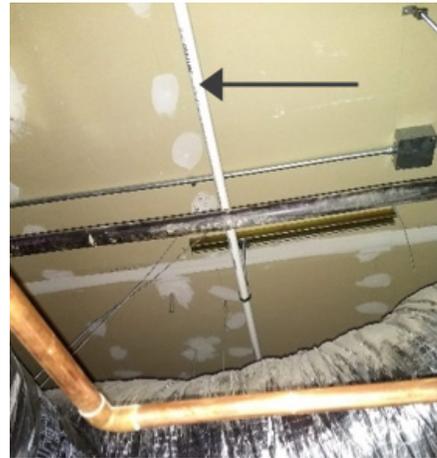
CONDENSATE DRAIN PIPING

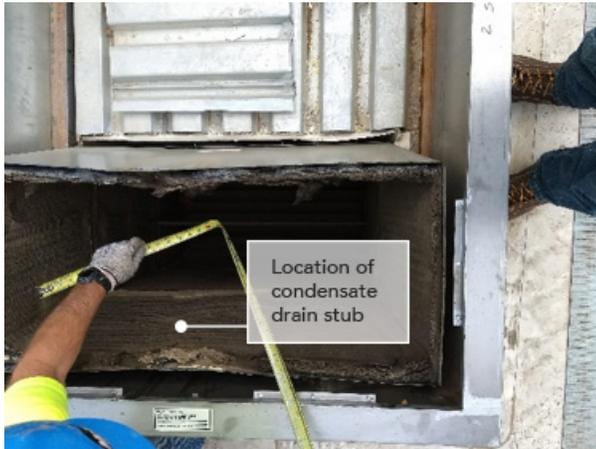
SUPPLY DUCT OPENING
(ROOF OR TOP VIEW)

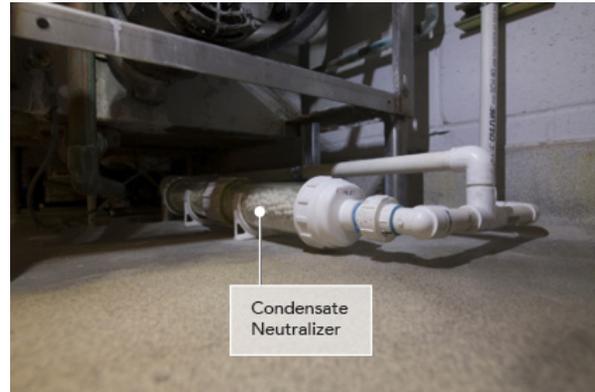
CONDENSATE NEUTRALIZER INSTALLED

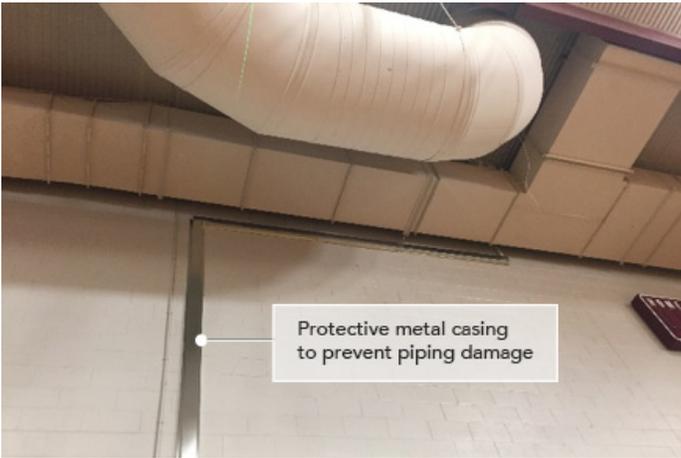
DRAIN PIPING WITH PROTECTIVE CASING

The installing contractor elected to run most of the condensate drain three days before the installation day. The C-RTU is located on the roof of a gymnasium and a scissor lift was required to access the 30-foot ceiling where the drain piping penetrates the roof. The contractor ran 1 ¼" PVC pipe down the gym wall and into a storage room where a small air compressor and floor drain are located. A protective casing was installed over the PVC pipe to prevent damage to the drain piping from gym activities. Despite the height of the space, this condensate installation was the most straightforward of the four sites and required the fewest labor hours and lowest overall installation cost.

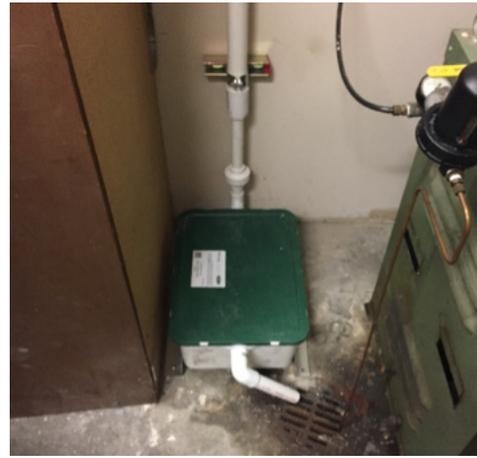
CONDENSATE NEUTRALIZER INSTALLED

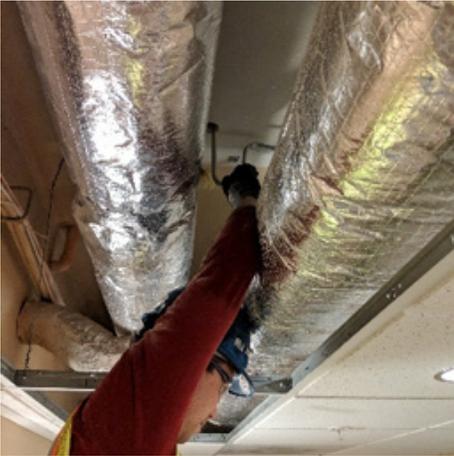
DRAIN PENETRATION & P-TRAP

Site D's condensate drain system was the fourth system installed by the installing contractor. As the pipe fitters were very familiar with the equipment, best practices, and manufacturer recommendations, the system was installed with few surprises or major challenges. Even so, the pipefitters required 33 hours of labor to complete the installation. The installer routed the drain pipe directly below the unit into the conditioned fifth floor above a T-bar ceiling. They routed the piping about 30 feet to a laundry room floor sink. A corridor transition space with hard-top ceilings and fire-rated wall lies between the T-bar ceiling and the laundry room. The firewall had to be penetrated and resealed, and, in order to maintain the required slope on the drain piping above the hard ceiling, the installers cut four 1 sq. ft. access panels. The site maintenance staff preferred to repair these panels themselves.

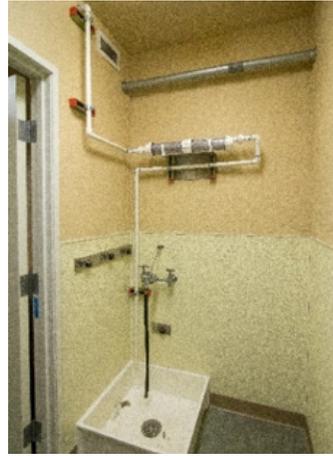
CONDENSATE NEUTRALIZER INSTALLED

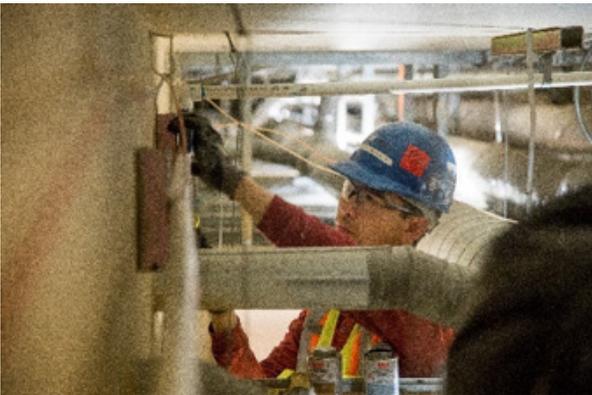
CONDENSATE DRAIN PIPING

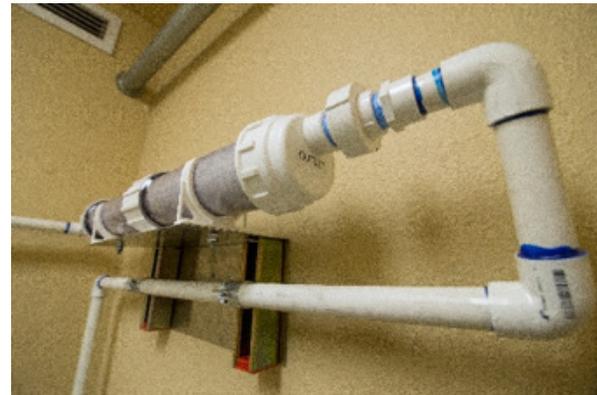
NEUTRALIZER

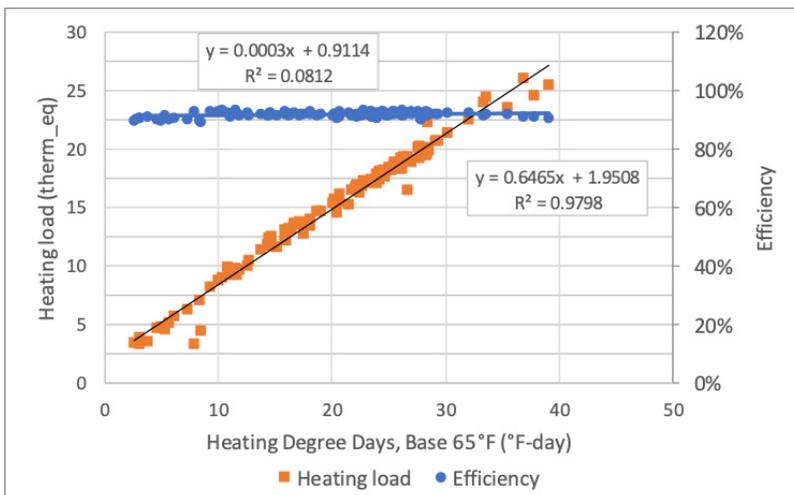
Site D Weather Regressions: Daily Heating Load & Efficiency
